Technical Report

CATHODIC PROTECTION SYSTEM

FOR FLEET MOORINGS

Technical Report R-702

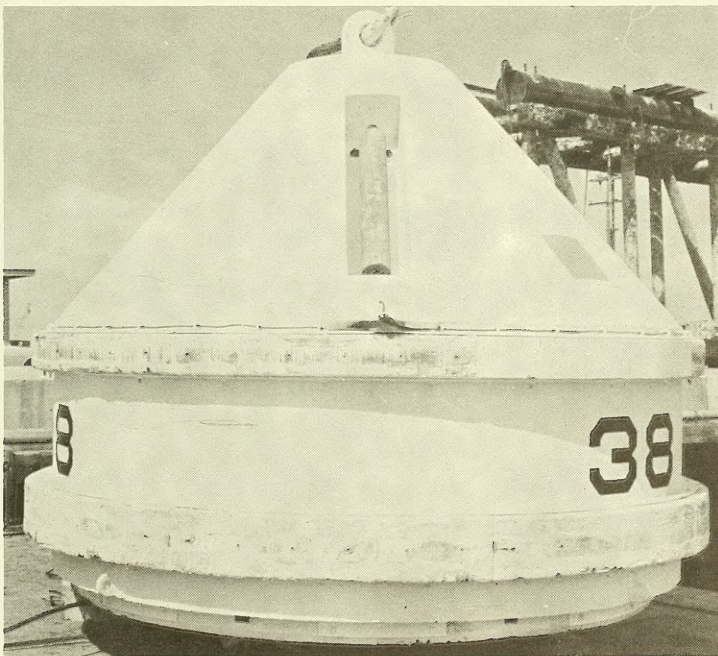
Figure 4. Inverted test buoy showing the square-foot area of bare steel on lower left of cone and location of the ground cables.

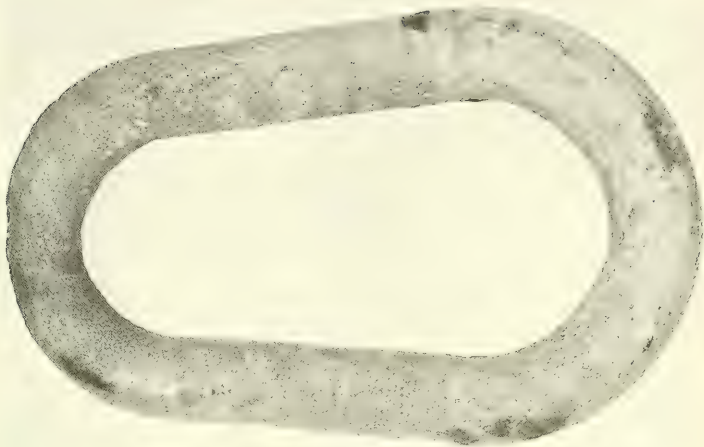
The total cost for rehabilitation of the control mooring amounted to \$4,617 of which \$2,000 was for pickup and installation and \$2,617 was for repairs. The unprotected ground ring assembly was loose, and all rivets needed replacing. The pear links were badly pitted, and the thickness was reduced in places to 1-1/2 inches (a loss of 40%), necessitating their replacement (Figure 13). The chain thickness for the first five links on all legs had been reduced to about 1-7/8 inches.

Figure 13. Pear link from control mooring showing pitting and greatly reduced thickness.

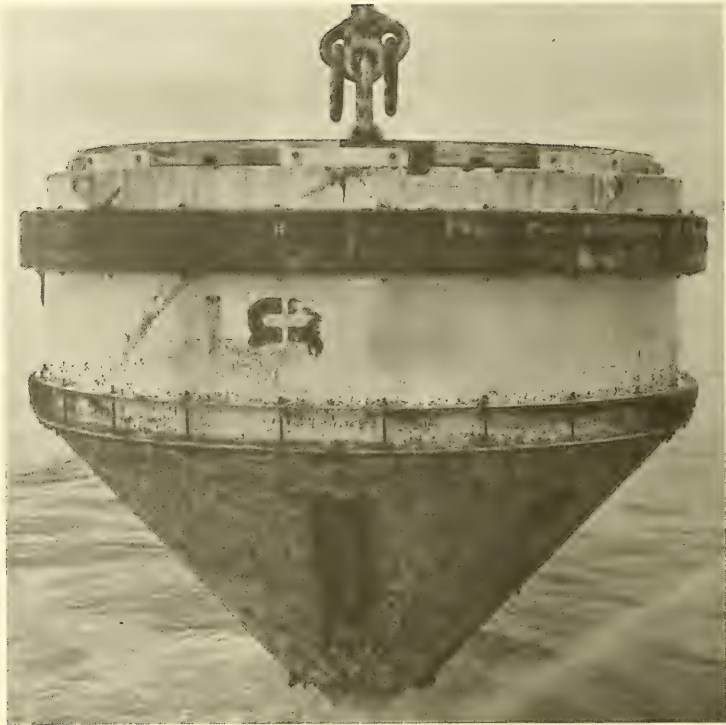
Twenty-three months after relocation of the cathodically protected mooring, the buoy was lifted from the water for its annual inspection. The buoy and the entire riser-chain was hosed with seawater (Figure 16) to remove the attached fouling organisms. The buoy had lost about half of its lower fender from marine borer attack. There was very little coating damage

(mostly from abrasion) and no detectable rusting of steel below water except for the square of exposed steel that had a hard tight film of rust but no pitting or active corrosion. Rather heavy marine fouling had accumulated since the buoy was washed 1 year earlier. Fouling included tunicates, barnacles, green algae, mussels, and tube worms.

Figure 16. Cleaned buoy 23 months after relocation. Note the lost section of lower fender, the anode in the sea chest, and the square of bare steel.

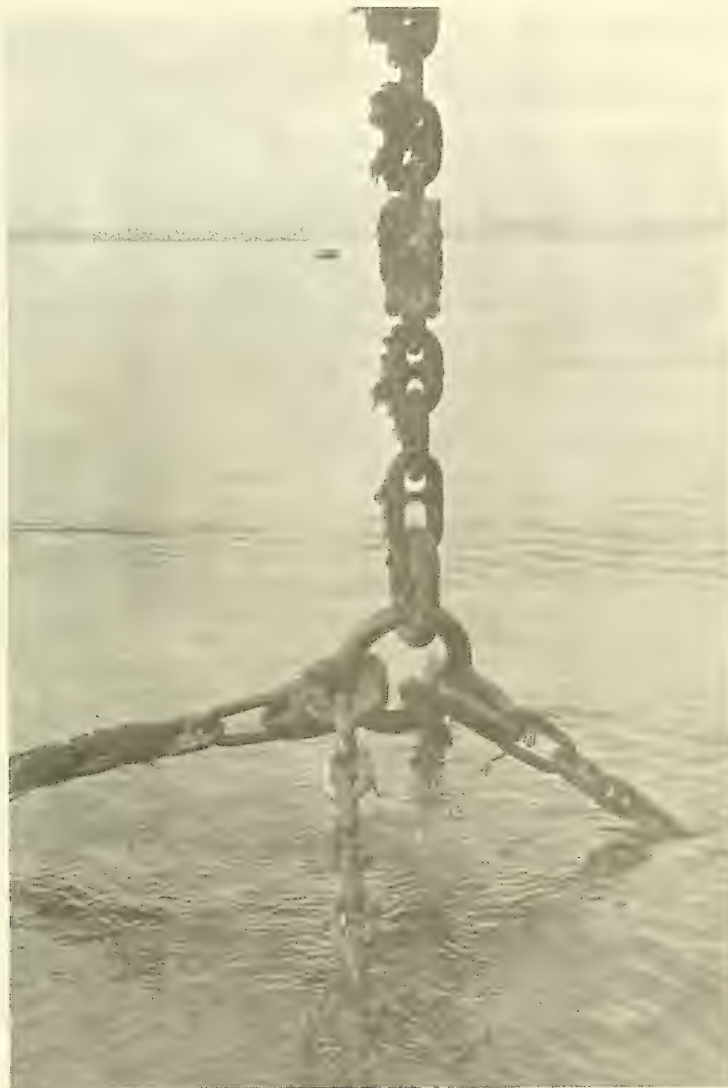
About one-third of the zinc anodes in the sea chests had been lost, and only about one-tenth of the zinc anodes on the riser-chain (Figure 17) had been lost. The divers who assisted in measuring the potentials indicated that the anodes on the ground legs were in a similar condition.

The riser-chain and ground ring assembly were in excellent condition (Figure 17) with no apparent corrosion. The chain diameter remained at 2-1/2 inches. The ends of the four steel cables that terminated near the ground ring had been pulled loose from their connections to the chains. Welds had been broken from two of the legs, and the cables had been pulled from the cable clamps that remained on the other two legs. This area still had sufficient electrical continuity for complete cathodic protection.

Figure 17. Ground ring assembly and riser-chain with anode 23 months after relocation.
